EMERGENCY ACTION PLAN

ROANOKE CREEK DAM #72A

VA DCR #037002

July 2020

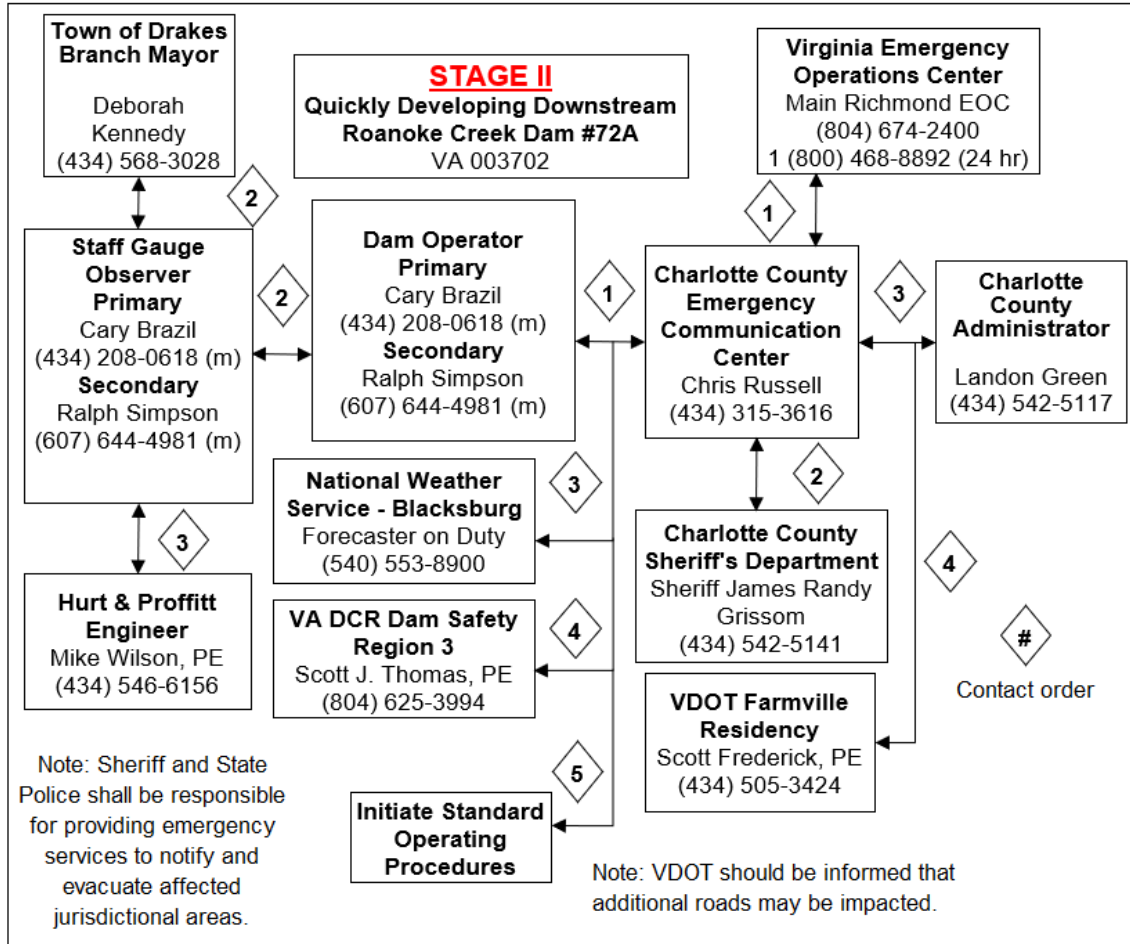
B. STAGE II NOTIFICATION

Message from dam operator to Charlotte County Emergency Communication Center: *I am at Roanoke Creek Dam #72A (or have been to the dam) and the water level has risen into the emergency spillway to the threshold established in the emergency action plan to move to the Stage II Emergency Level. Based on the current situation, the dam is at a STAGE II condition. Please prepare your personnel in case an evacuation is necessary and continue to initiate your standard operating procedures (SOP). I will be observing the dam and emergency spillway every 2 hours.*

Note: Standard Operating Procedures shall include notification of the evacuation team, contacting the National Weather Service for rainfall projections, and contacting the Virginia Emergency Operations Center. Charlotte County Emergency Communication Center is the local Emergency Operations Center.

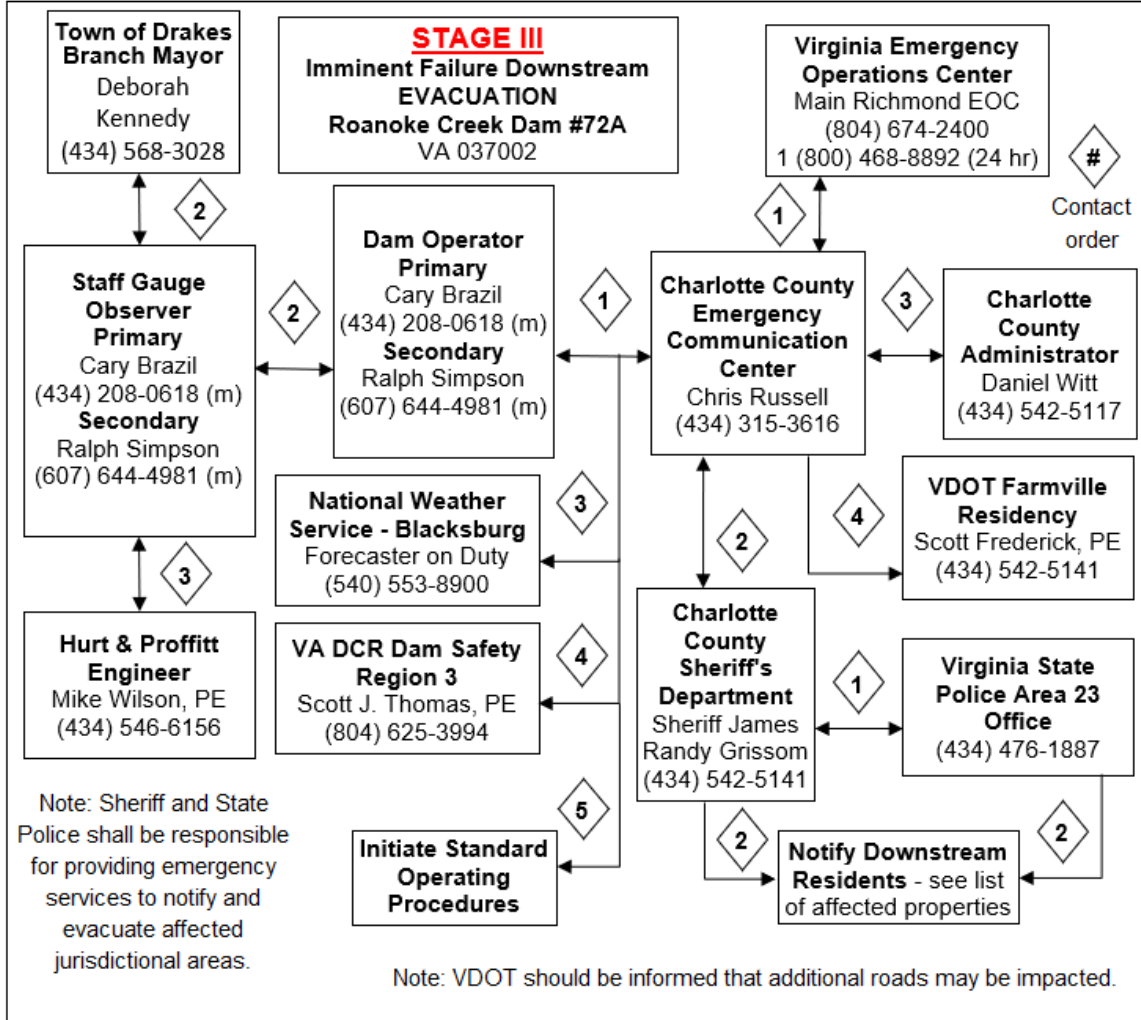
C. STAGE III NOTIFICATION

Message from dam operator to Charlotte County Emergency Communication Center: *I am at Roanoke Creek Dam #72A and the water level has risen in the emergency spillway to the threshold established in the emergency action plan to move to the Stage III Emergency level. Based on the current situation, the dam is at a STAGE III condition. Please proceed with the Standard Operating Procedures. I will remain at the dam to monitor continuously until the dam breaks or the water level recedes to safe levels and the Charlotte County Emergency Communication Center directs me to terminate my responsibility.*

Note: Charlotte County Emergency Communication Center is the local Emergency Operations Center.

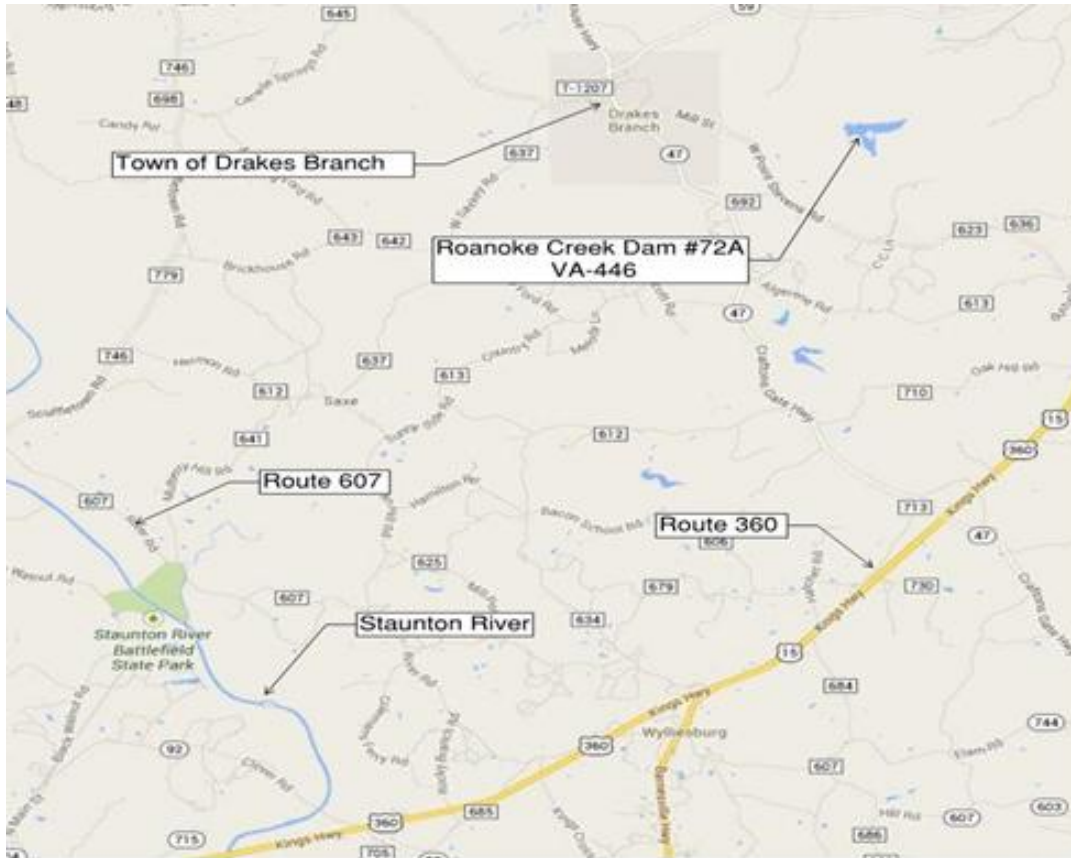
VA037002 Roanoke Creek Dam #72A – EAP Dam Access Map

Created by: David P. Wilmoth, PE, CFM, PH; Hurt & Proffitt, Inc.
Note: Map Not to Scale

Access to Dam from Town of Drakes Branch: Access road located approximately 0.7 miles southeast of the Route 623 W Point Stevens Road & Route 692 WPA Road intersection (**MAP POINT A**). Turn left (northeast) on the gravel road and follow approximately 1.7 miles to Dam. Please note gravel road is gated approximately half-way to the Dam.

Access to Dam from Rt. 623 W Point Stevens Road (heading northwest towards Drakes Branch from US 360): Access road located approximately 2.4 miles northwest of the Rt. 623 W Point Stevens Road & County Route 636 intersection (**MAP POINT B**). Turn right (northeast) on the gravel road and follow approximately 1.7 miles to Dam. Please note gravel road is gated approximately half-way to the Dam.

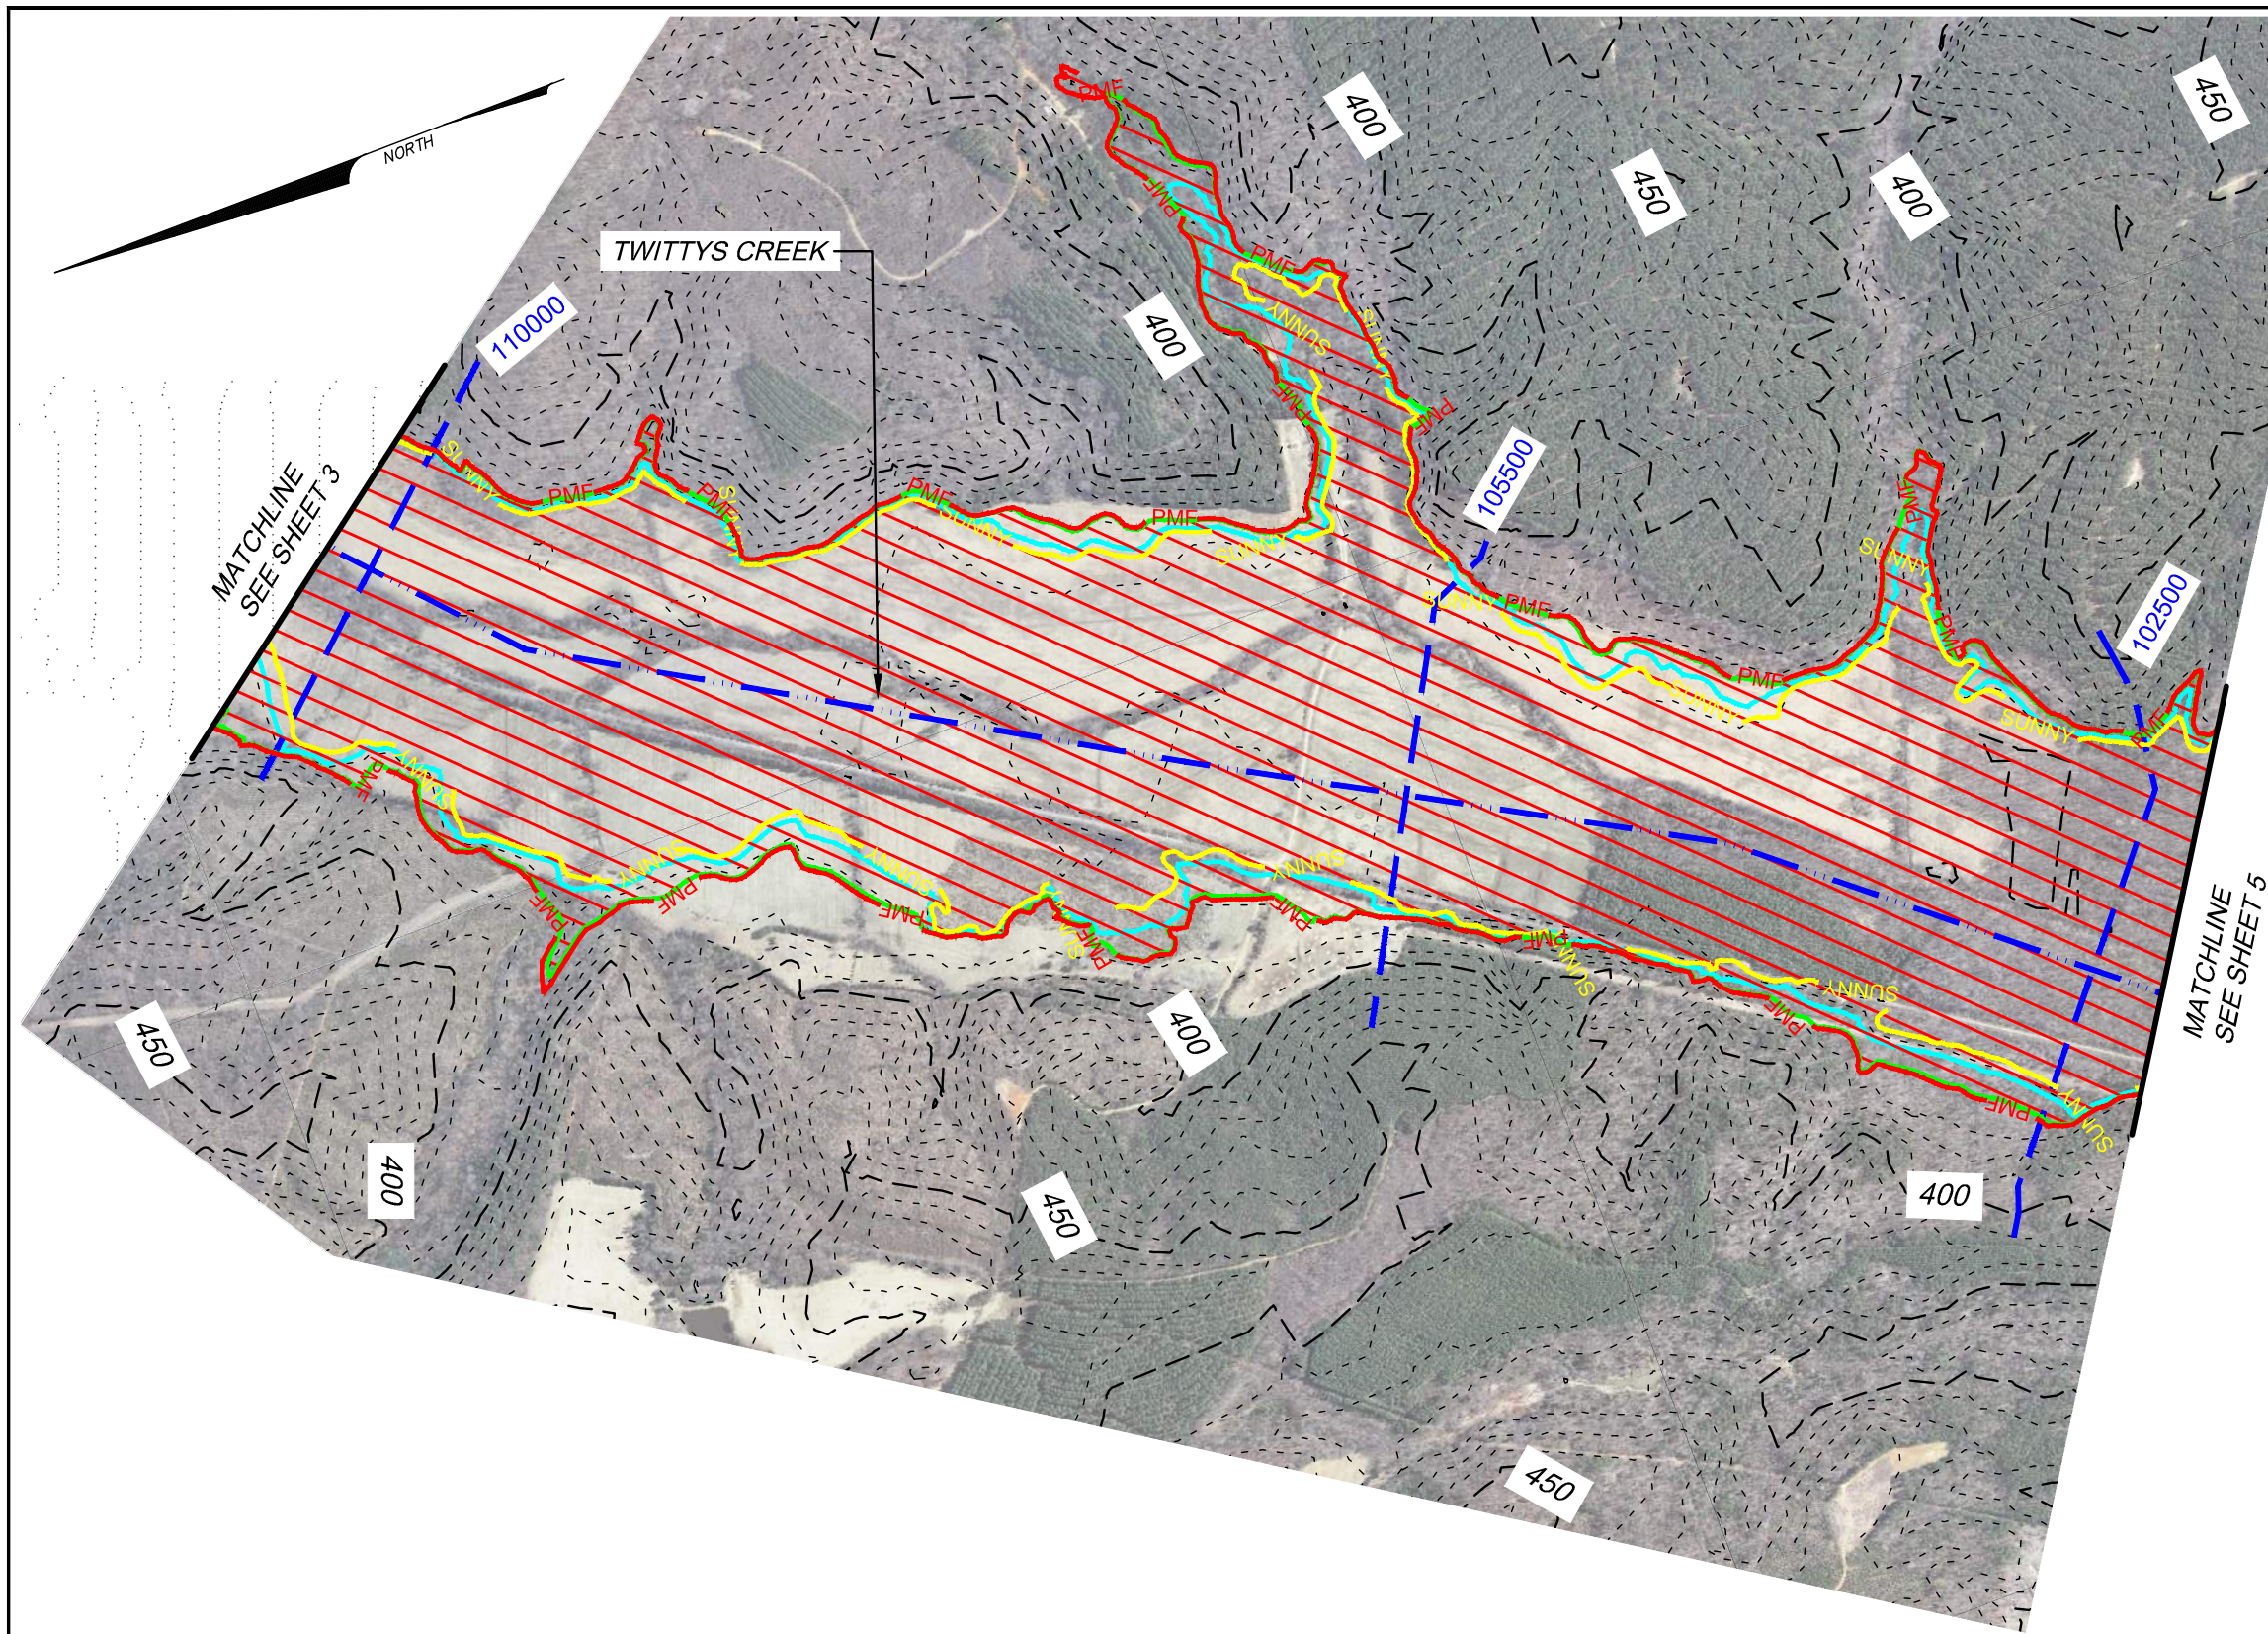
PROJECT NO.	20130453	SHEET NO. 4 OF 15
G.L. NO.	304-09-D3.7	
FILE NO.	G-13962	
DATE:	12/06/13	
DRAWN BY:	SHC	
CHECKED BY:	MDW

INUNDATION ZONE MAP
DAM BREACH FLOOD ELEVATIONS
ROANOKE CREEK DAM #72A
DRAKES BRANCH, VA

A Dam Break Inundation Zone Study was completed by Hurt & Proffitt, Inc. in December of 2013 which included the development of dam break inundation maps (dated 12/06/13). Inundation maps on the following sheets were obtained from the December 2013 Hurt & Proffitt Dam Break Inundation Zone Study.

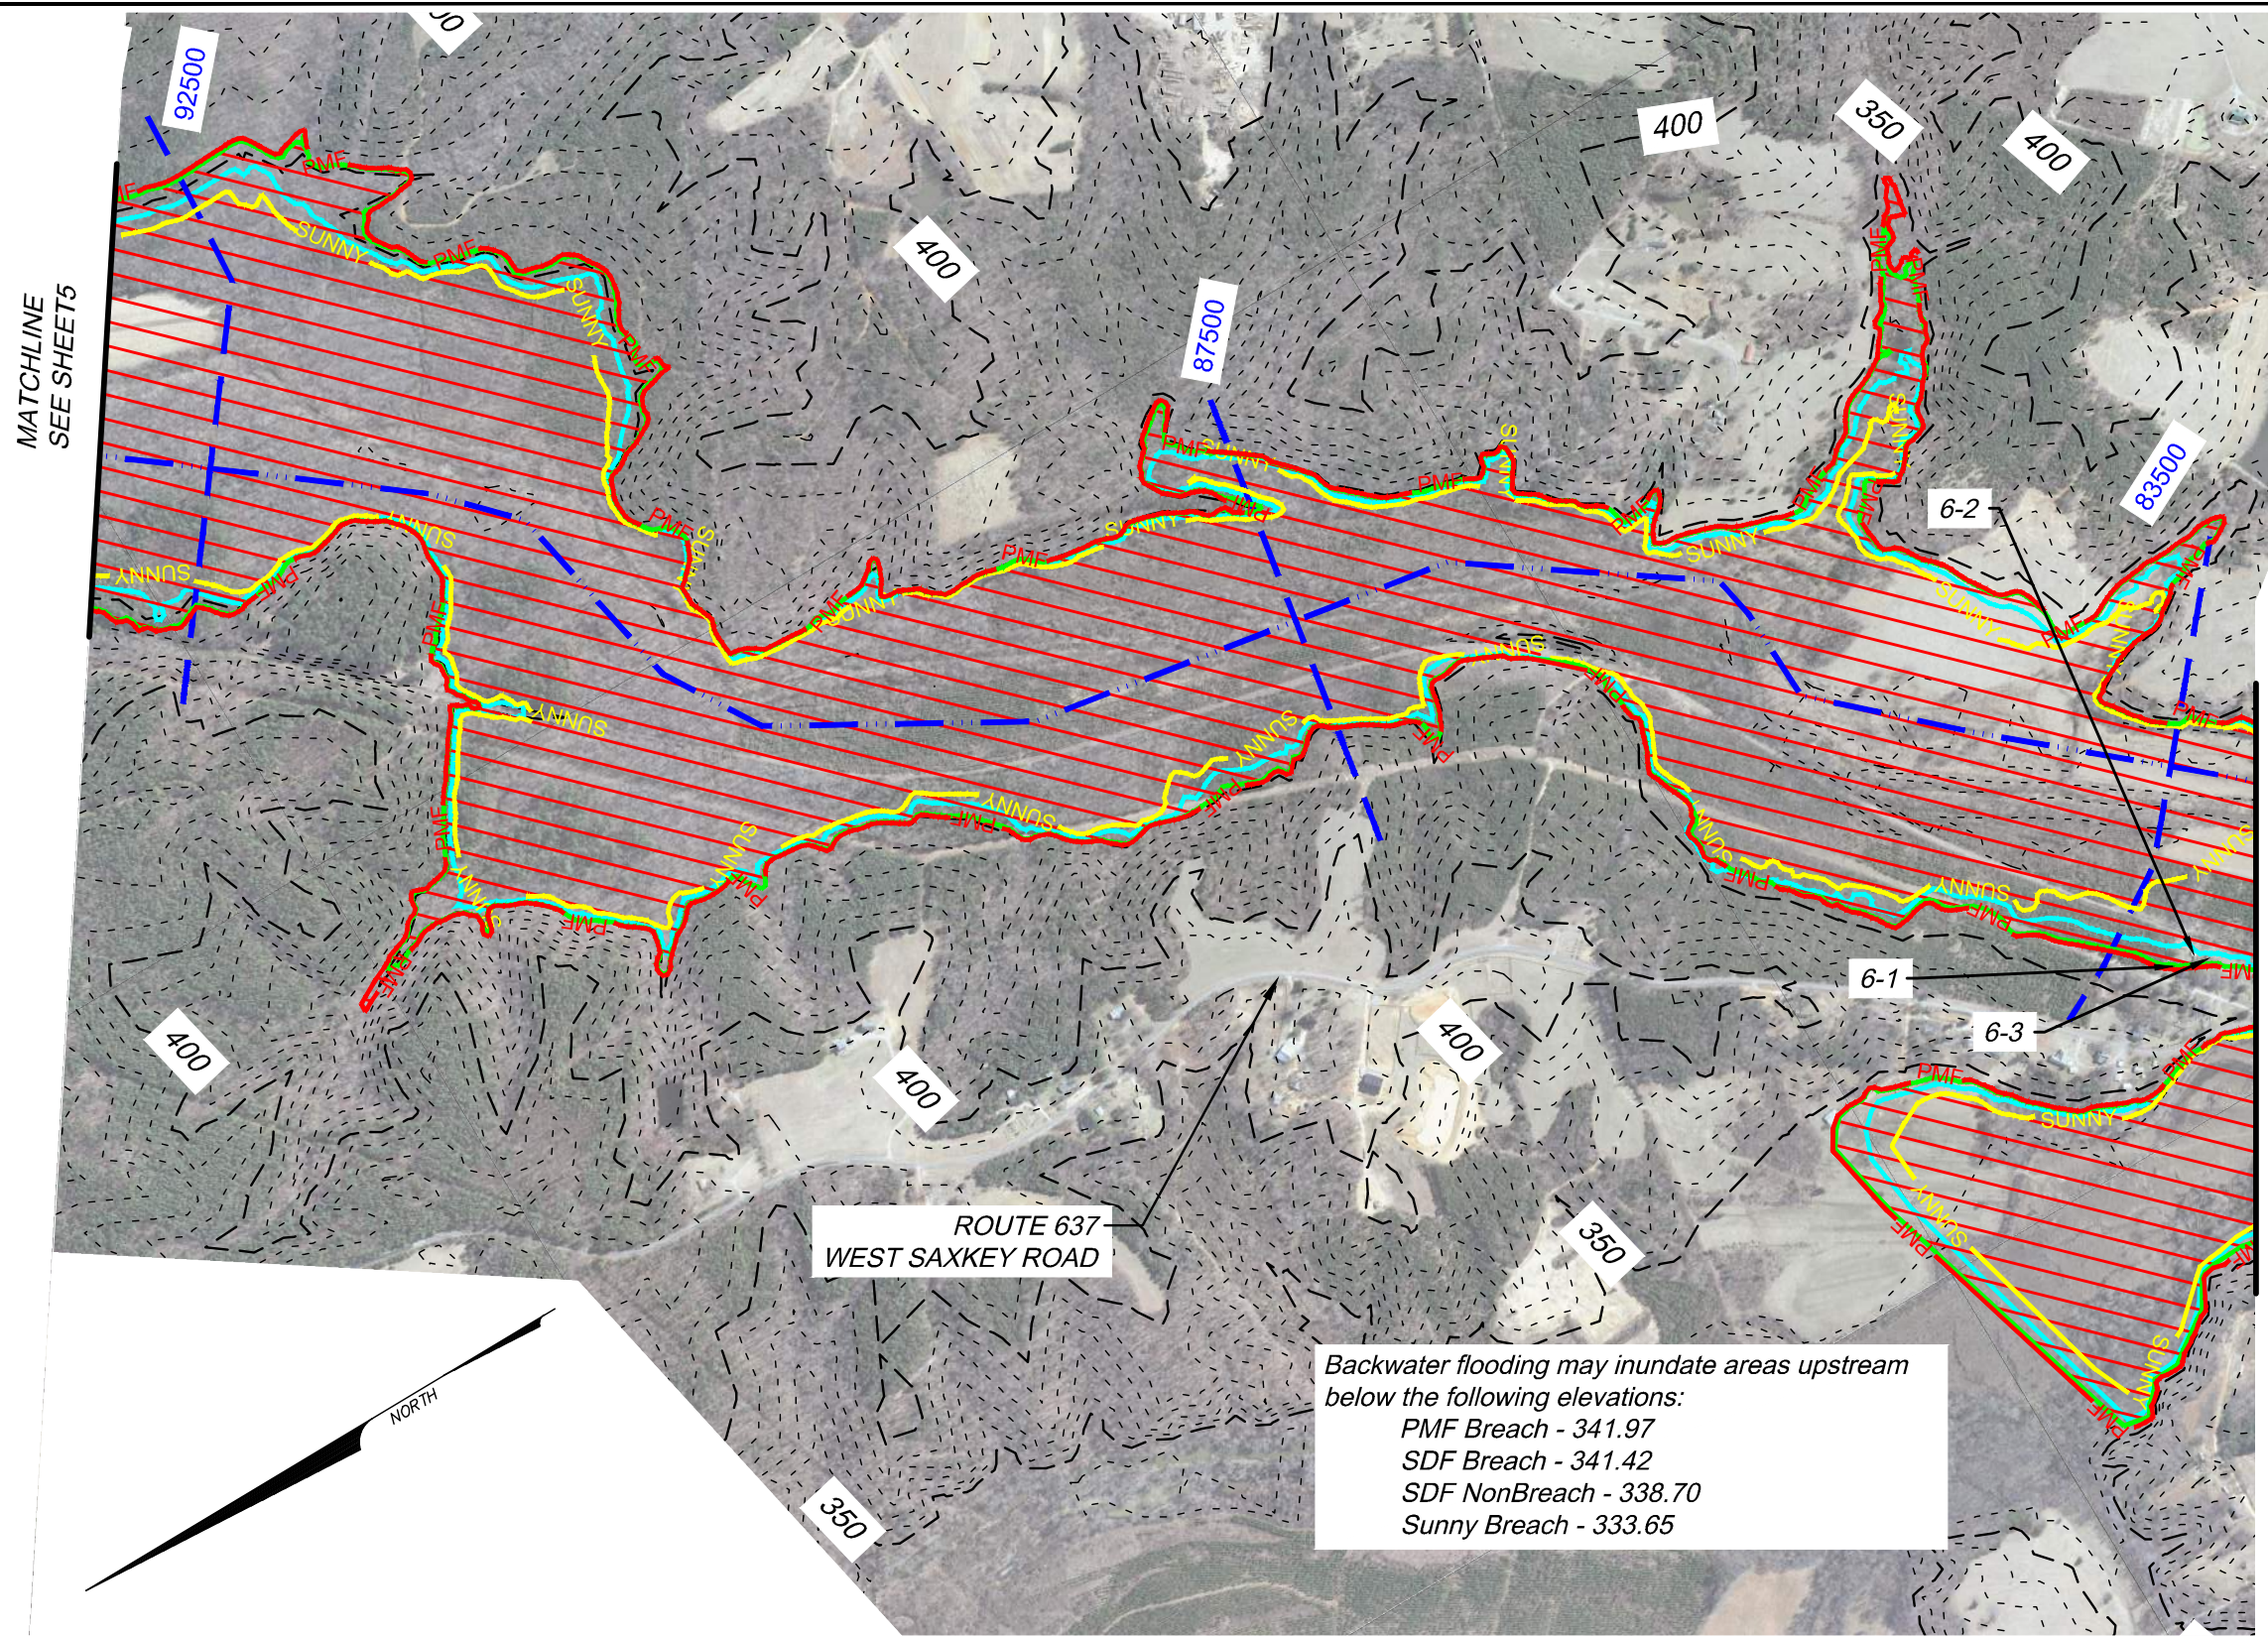
PROJECT NO.	20130453	SHEET NO. 6 OF 15
G.L. NO.	304-09-D3.7	
FILE NO.	G-13962	
DATE:	12/06/13	
CHECKED BY:	MDW	
DRAWN BY:	SHC

The information contained on this map is prepared for use in the notification of downstream property owners by emergency response personnel.

Aerial mapping and digital contours taken from GIS Information for Charlotte County, VA. Areas at dams and road crossings were field surveyed by Hurt & Proffitt, Inc.

INUNDATION ZONE MAP
DAM BREACH FLOOD ELEVATIONS
ROANOKE CREEK DAM #72A
DRAKES BRANCH, VA

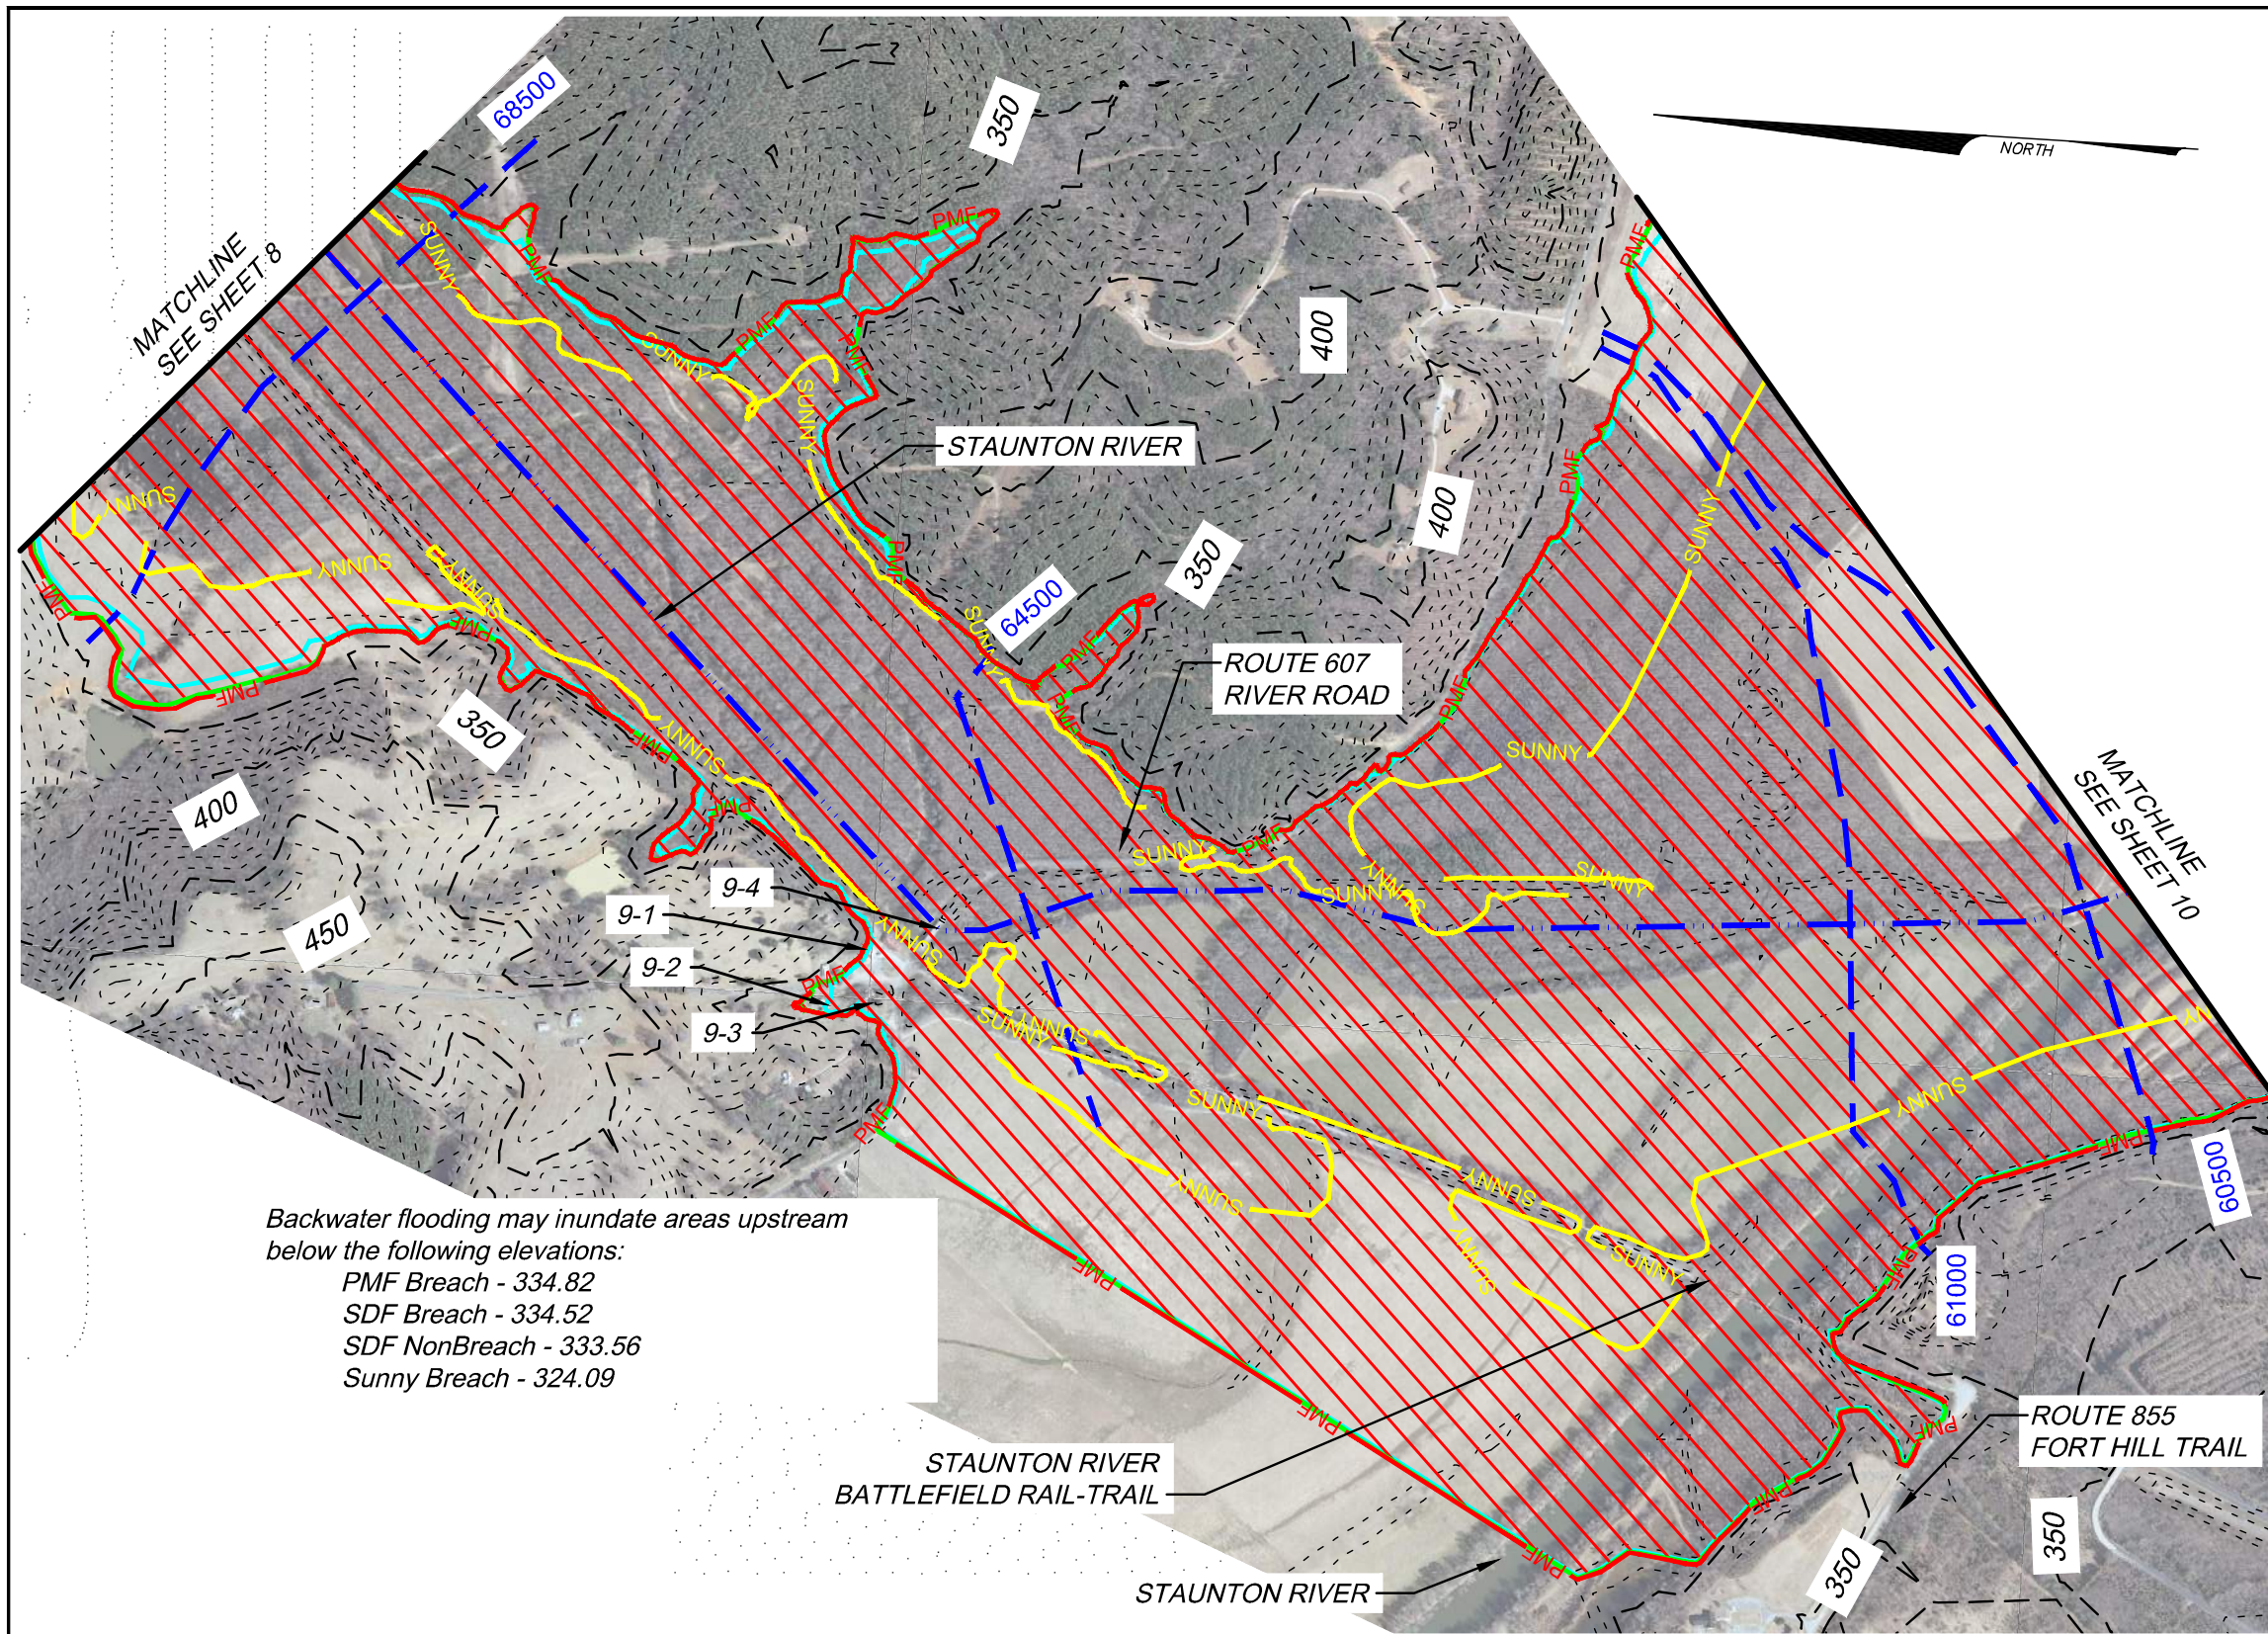
PROJECT NO.	20130453	SHEET NO. 9 OF 15
G.L. NO.	304-09-D3.7	
FILE NO.	G-13962	
DATE:	12/06/13	
CHECKED BY:	MDW	
DRAWN BY:	SHC

INUNDATION ZONE MAP
DAM BREACH FLOOD ELEVATIONS
ROANOKE CREEK DAM #72A
DRAKES BRANCH, VA
